Bayshore Embassy Condominium
SIRS Components
Fort Lauderdale, FL

Report #: 51938-0
Beginning: January 1, 2025
Expires: December 31, 2025

RESERVE STUDY
"Full"

April 12, 2024

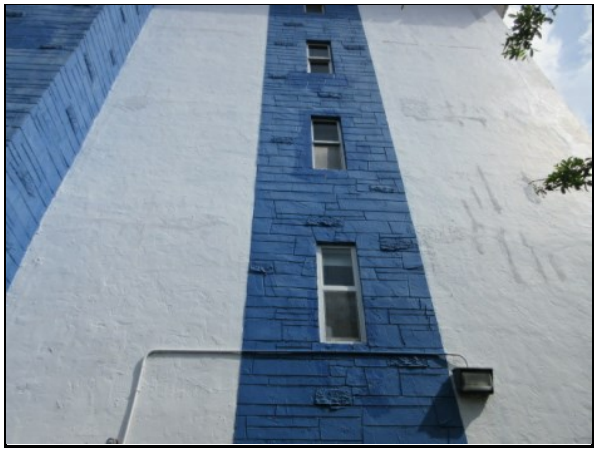
Useful Life:
7 years

Remaining Life:
0 years

Best Case:	$ 28,800	Worst Case:	$ 35,200
	Lower allowance for partial restoration		Higher allowance
